Army Aircraft Safety Performance

REVIEW

- FY 89 through FY 93 -

- UH-1
- H-60
- AH-1
- AH-64
- H-47D/E
- OH-58A/C
- OH-58D
- Fixed Wing

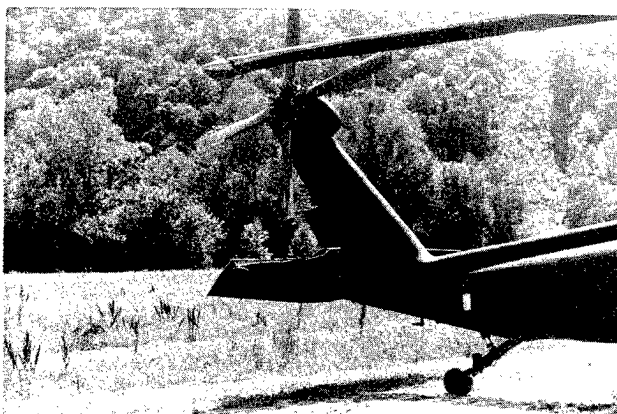
Scenario 1. Crewmembers were under NVDs as the aircraft departed the NOE route en route to the airfield. The PC became momentarily fixated on a bridge that was not on the crew's map. The PI on the flight controls began a climb and sighted wires at very close range. He pitched the aircraft's nose up in order to "belly" into the wires. The aircraft struck high-power lines and the crew executed an emergency landing to a grass airstrip.

■ **Result:** Damage cost of \$1,007,500.

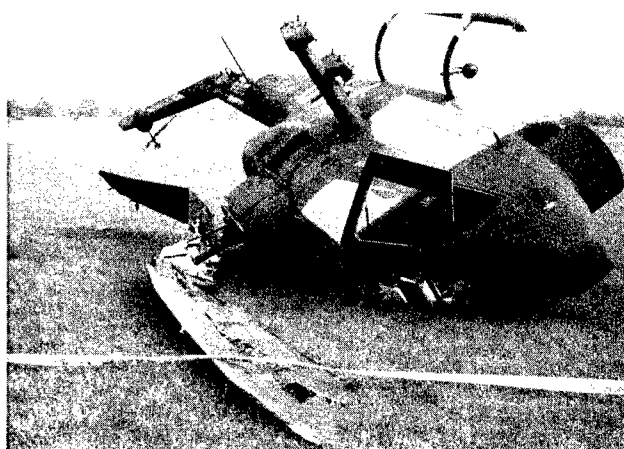
35 to 45 degrees. At this point, the IP interpreted the large yaw as an indication of an engine failure. At 40 to 45 feet AGL, the IP initiated an autorotation by reducing the throttle. Immediately after closing the throttle, the IP began applying collective pitch and simultaneously trying to level the aircraft. The aircraft touched down with low rotor RPM, moved laterally to the right, rolled over, and came to rest on its right side.

- **Result:** Damage cost of \$192,316.

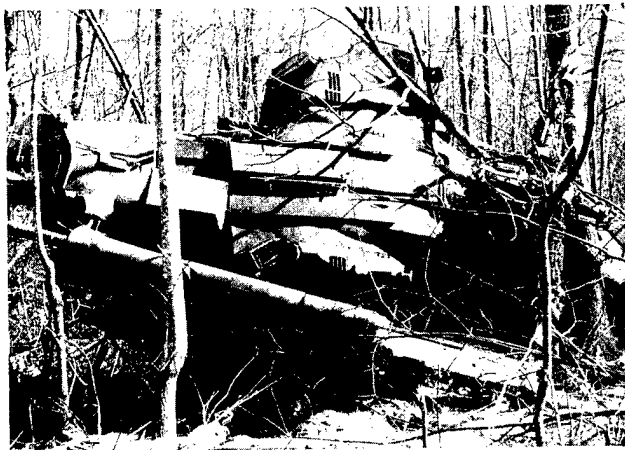
Scenario 1. The accident aircraft was Chalk 3 in a night, multiship, deep-attack, battalion training mission. The back-seater was using the pilot's night vision system (PNVS), and the front-seater was using the target acquisition designation sight (TADS) during battle-position operations. While in an out-of-ground-effect (OGE) hover, the aircraft entered a left, rearward, descending drift and struck trees with the main and tail rotor systems. The aircraft then began an uncontrolled right spin and impacted the ground on its right side in a nose-low attitude.

■ **Result:** One injury, a destroyed aircraft, and a cost of \$10,765,536.
